Air Safety Investigation →

Single Engine Final Report 1/8/18

Accident Date:	12/11/16
Aircraft Registration:	YS-332PE
Aircraft Manufacturer:	Piper 1977
Location:	Ingenio La Cabana, SV
On Scene Exam:	No
NTSB IIC:	Dan Baker

Accident Time (24 hr.): 13:07 UTC Air Safety Investigator: David Harsanyi, ASI Aircraft Model: PA-38-112 Aircraft S/N: 38-78A0663 Aircraft Damage: Destroyed NTSB Report# CEN17WA222

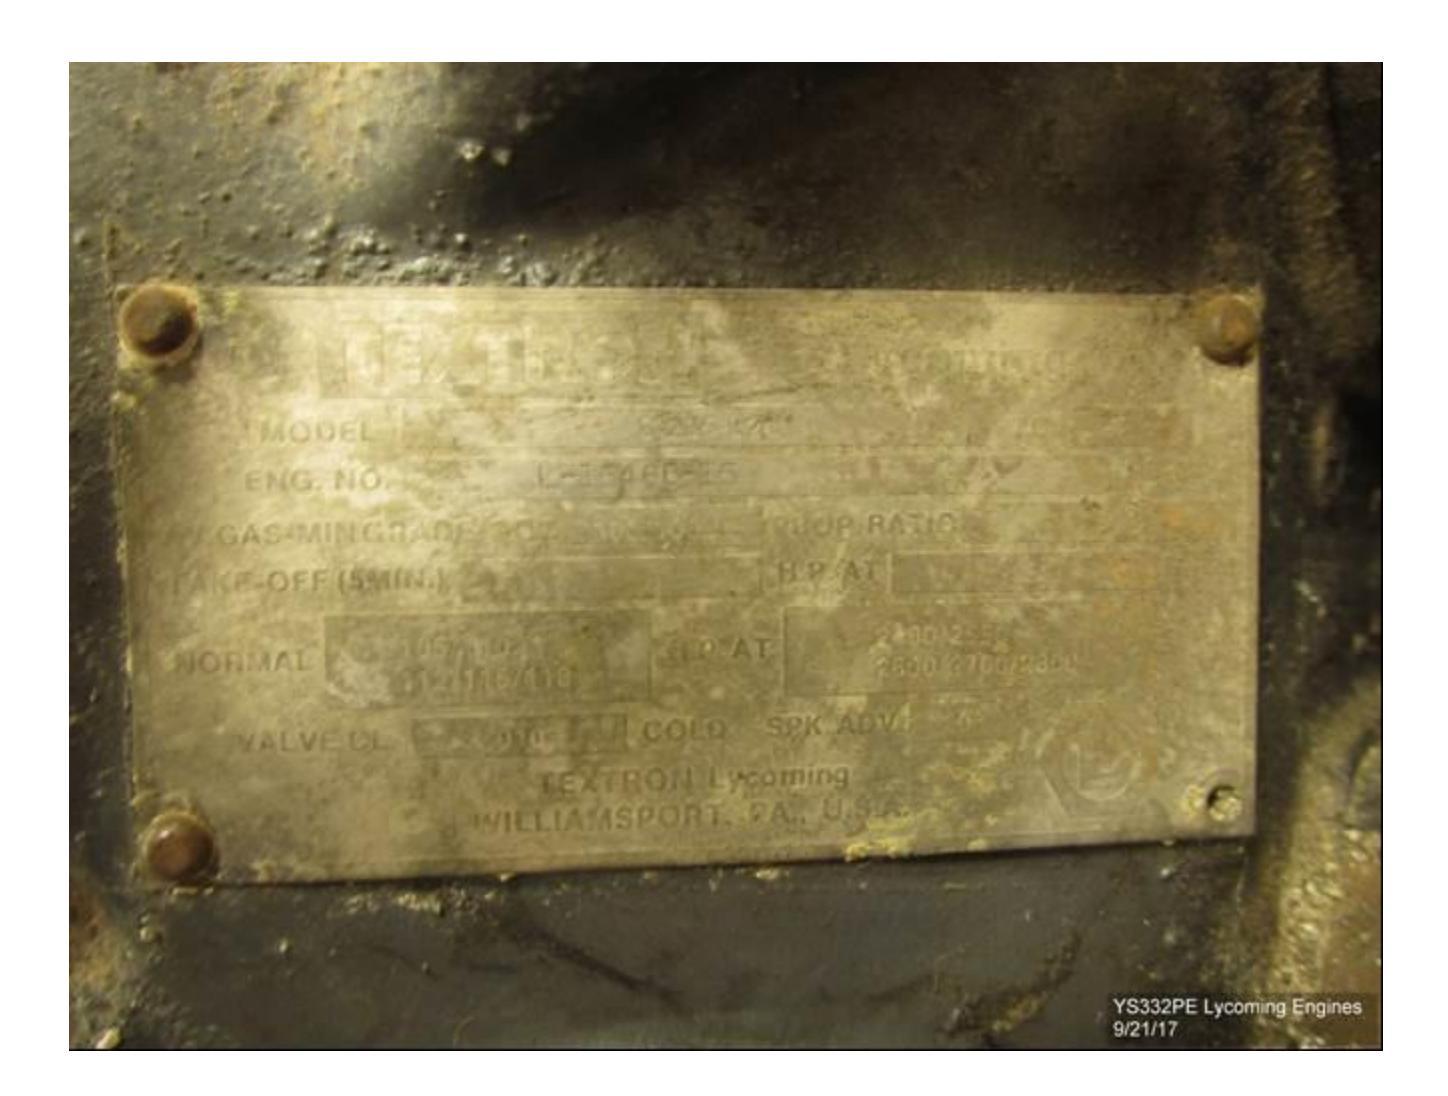
Model Serial Number		lumber		Total Time	
0-235-L2C		L-154	L-15468-15		161.5 Hours Since Field O/H
Above engine Information	: 🛛 Dataplate 🗌	Maintenar	nce Rec	ords 🗌 Other	
Dataplate Attached/Found? Xes No Exp		Experimer	ntal Eng	ine? 🗌 Yes 🖾 No	
Case Match # 2832	Engine S/	N on Case: L-16296-15		Cranks	shaft S/N: Undertermined

Maintenance Records Attached?	🛛 Yes 🗌 No	On-Scene Exam?	🗌 Yes 🛛 No
Post Recovery Exam?	🛛 Yes 🗌 No	Propeller Attached?	🗌 Yes 🖾 No
Engine Disturbed Prior to Your Arrival?	🛛 Yes 🗌 No	Engine Appear to be runable?	🗌 Yes 🛛 No
Does Crankshaft Rotate?	🖾 Yes 🗌 No	Evidence of pre-impact fire?	🗌 Yes 🖾 No
Does Clankshalt Rotate:		Evidence of pre-impact me

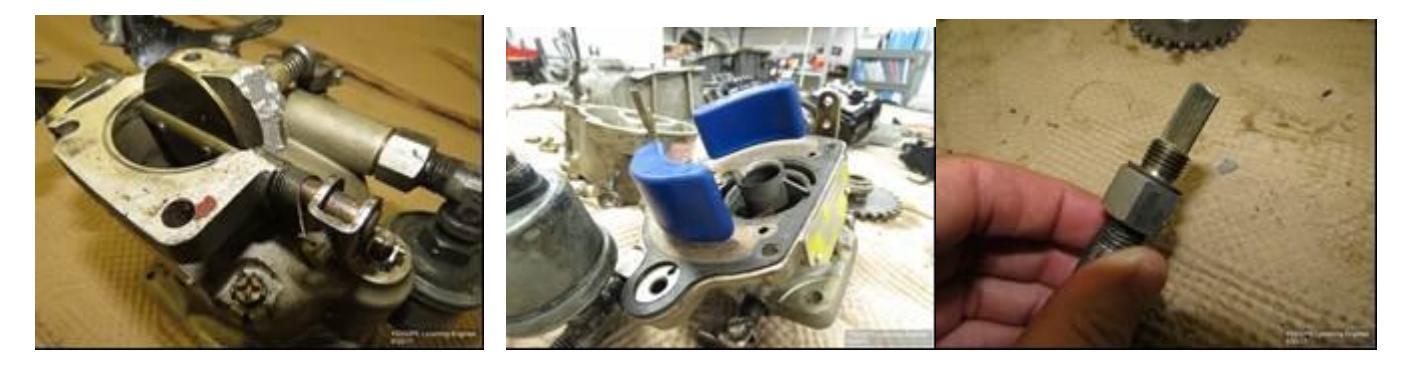
Carburetor arrived separated from the engine and showed signs of impact damage at time of the engine exam. Upon disassembly, the plastic floats remained intact inside the float bowl with no noted damage or cracks to the floats. Fuel inlet screen was clean and unobstructed upon inspection. Mating flange showed signs of impact damage on two of the four corners around bolt holes. No fuel was present in the float bowl as the drain plug had been removed prior to the engine arriving for exam.

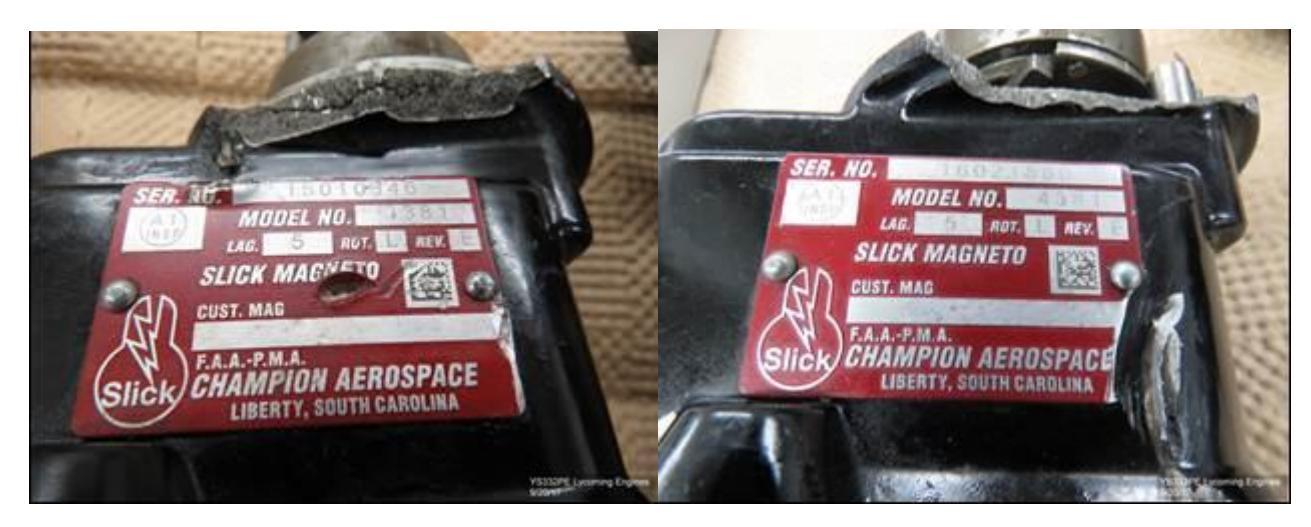
Both magnetos were sent with the engine for exam, but had been previously removed. Attach flange cracked on each magneto, both magnetos produced spark when rotated externally at each lead. No further testing completed on these components.

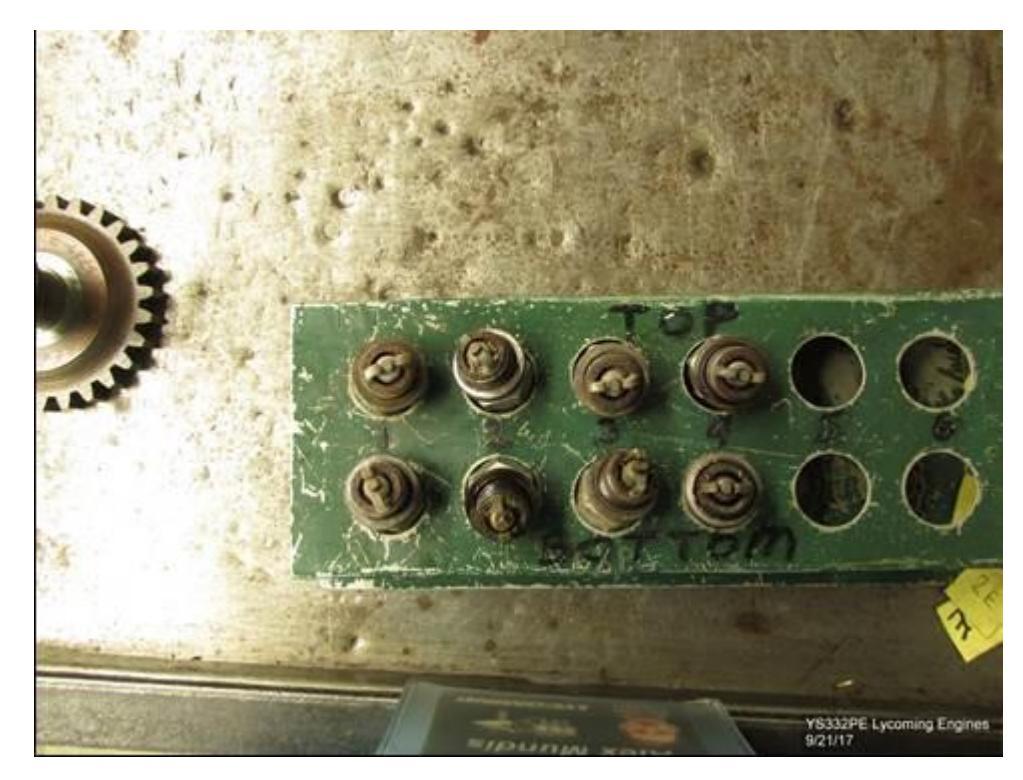
All spark plugs exhibited signs of rust on the ground electrode end and face. Bottom plugs showed signs of being oil soaked with engine oil, common with transportation and storage of an engine.

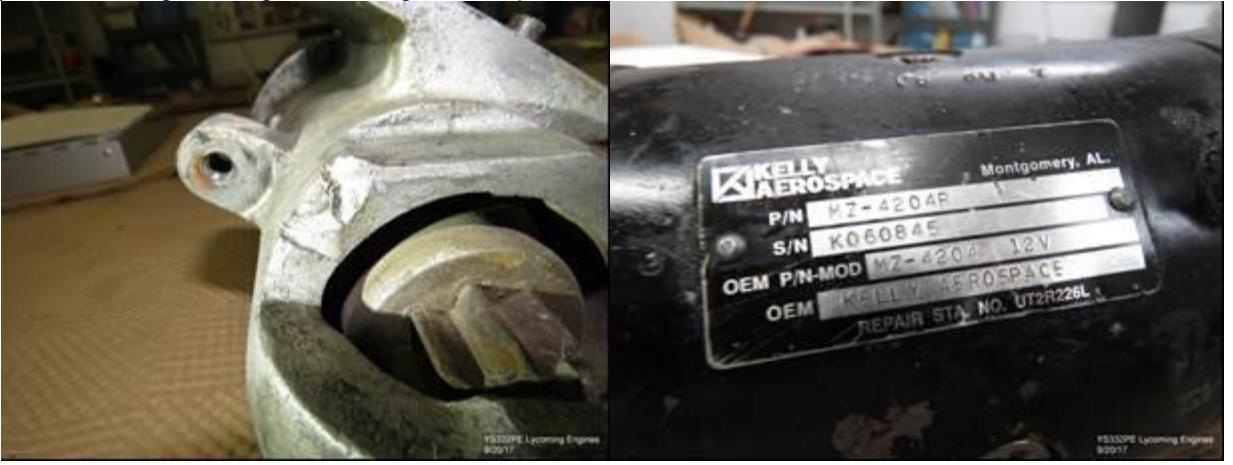
Engine arrived with starter removed. Starter housing showed signs of rotational scoring, typically seen from starter ring gear contacting housing at time of ground impact.

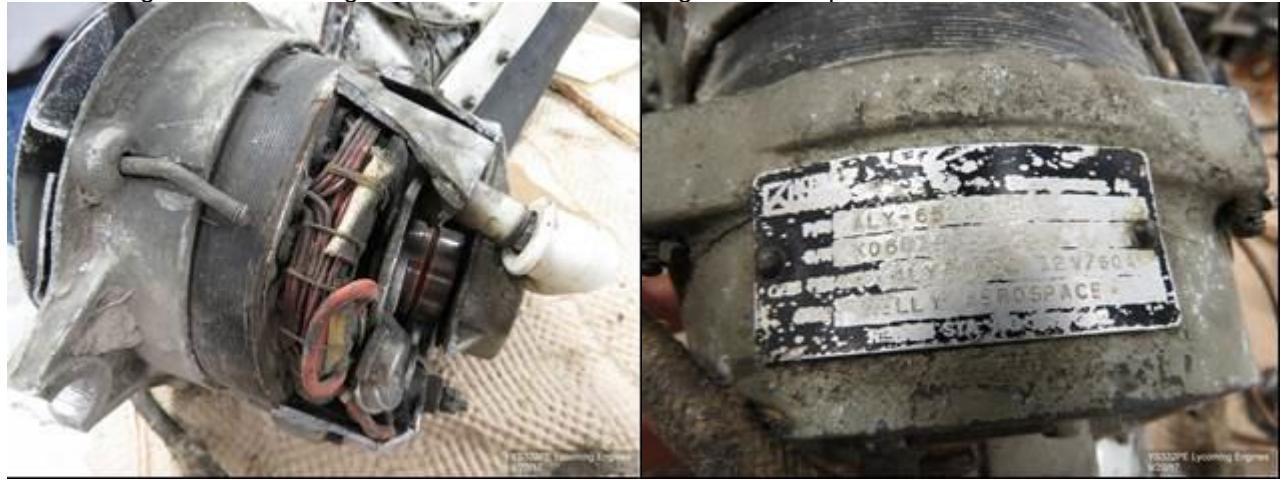
Housing of alternator fragmented with broken attachment points, likely due to impact damage. Alternator not attached to engine at time of engine exam. No further testing of this component.

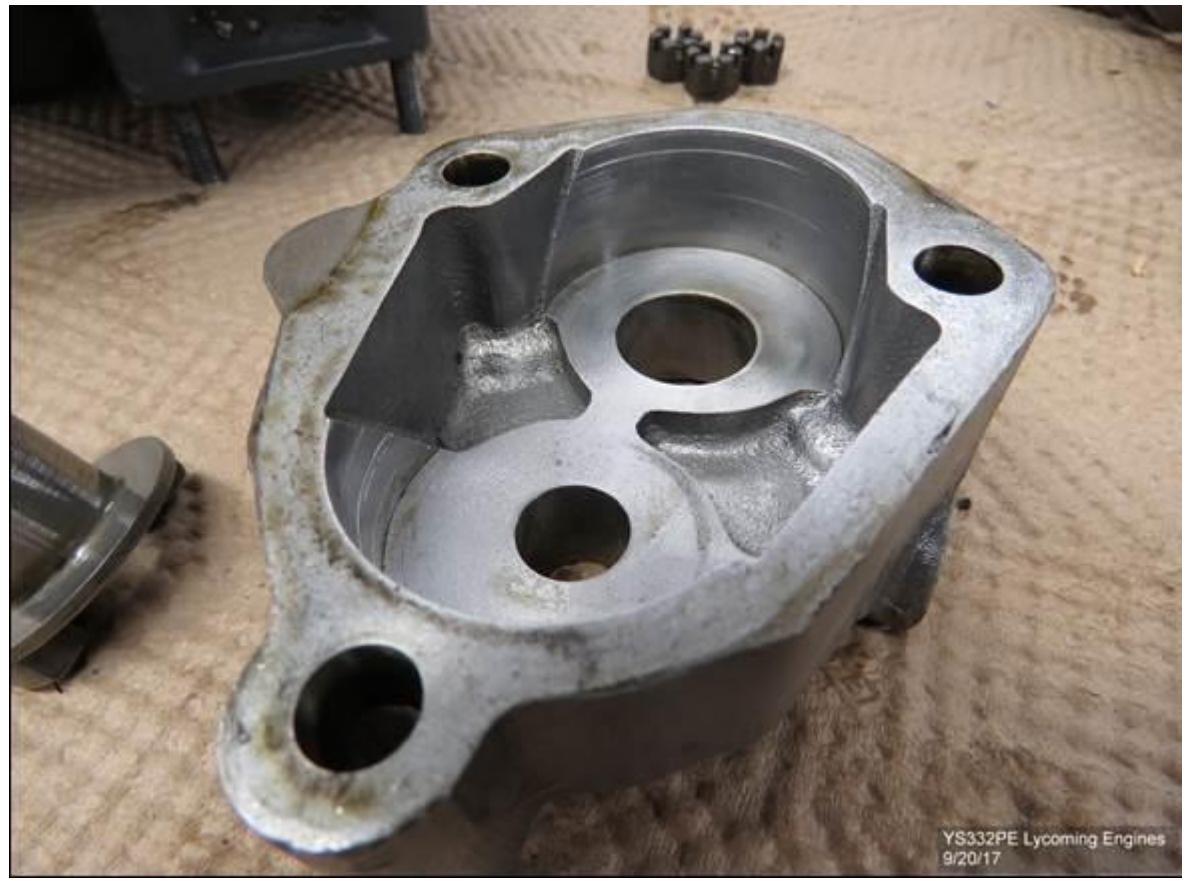
Light scoring found within oil pump housing, gears showed no signs of damage.

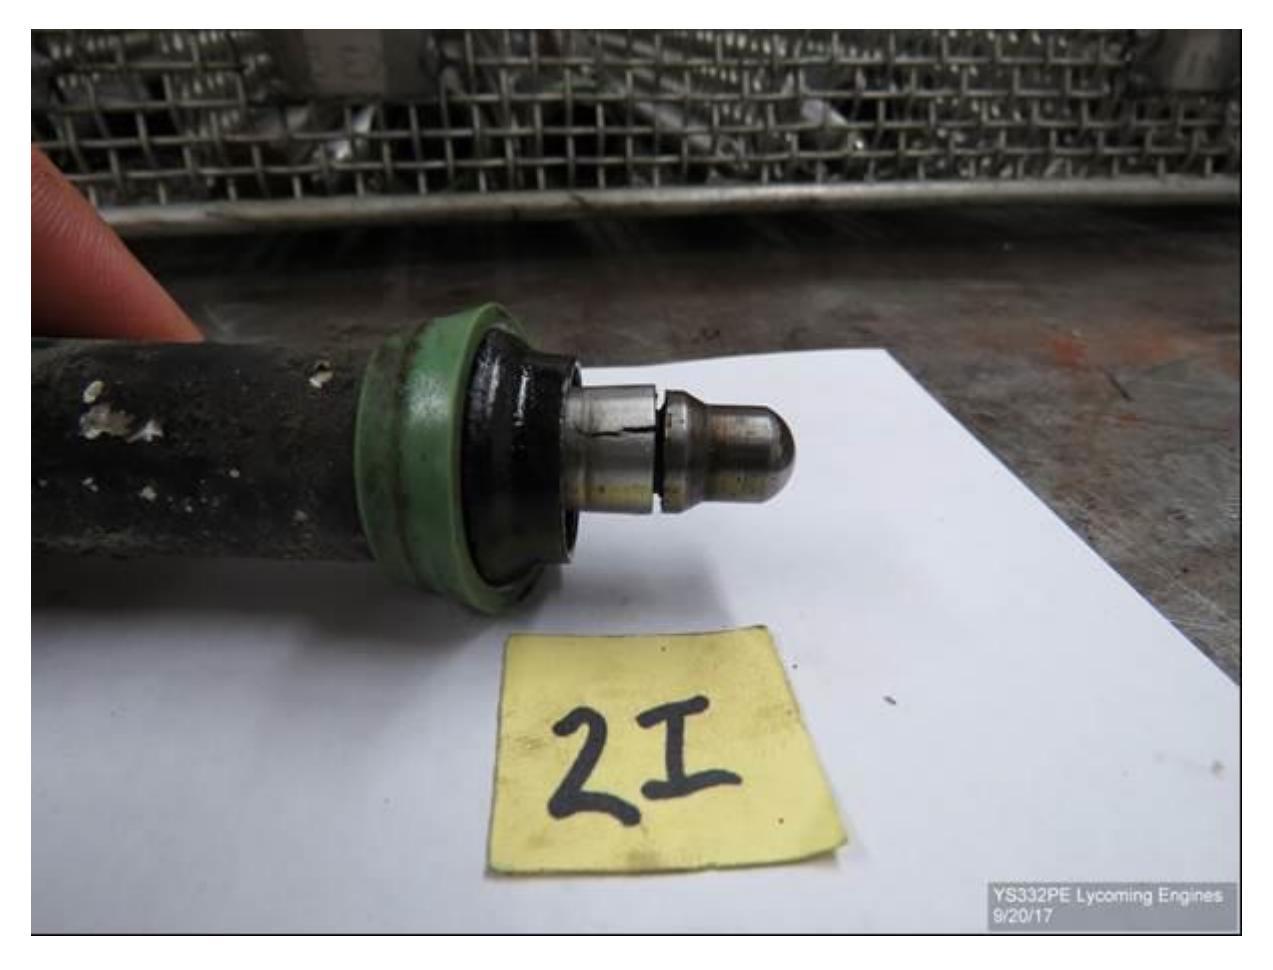
All pushrods within the engine showed varying signs of cracks, deformation, or other damage signatures.

- #1 and #3 pushrods show signs of wear /polishing around circumference of rod on valve end
- #1 exhaust pushrod found to be steel, corrosion present, all others in engine are aluminum
- #2 exhaust, aluminum pushrod with deep radial groove, small crack on one end
- #2 intake, multiple cracks on ends
- #3 exhaust, radial groove present on one end
- #4 exhaust, 1/2" wide depression on rod, crack on rod ends
